Příloha 1 - Fotodokumentace

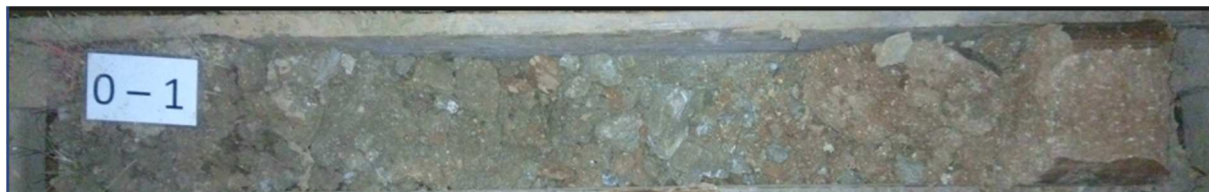
Foto 1 - HV110 (hnědozem: 0,0 – 0,2 m, navážka 0,2 – 0,7 m)

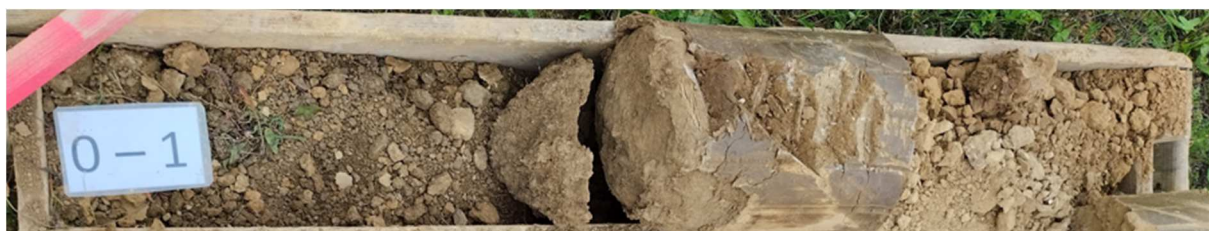
Foto 3 - J104 (hnědozem 0,0 – 0,6 m)

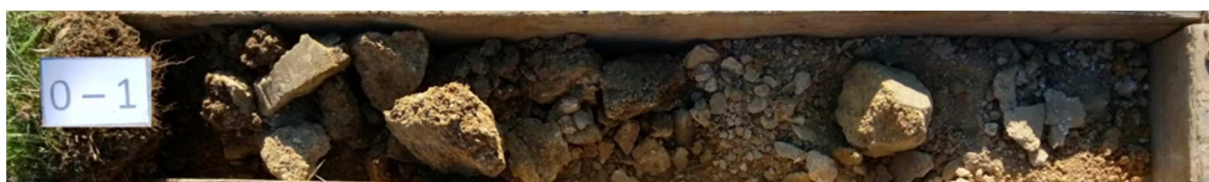
Foto 4 - J109 (hnědozem 0,0 – 0,2 m)

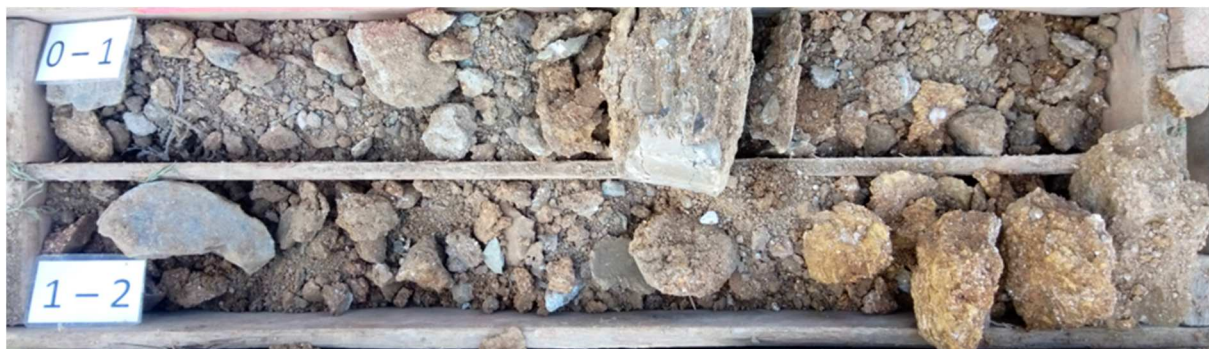
Foto 5 - J111 (navážka 0,0 – 1,5 m)

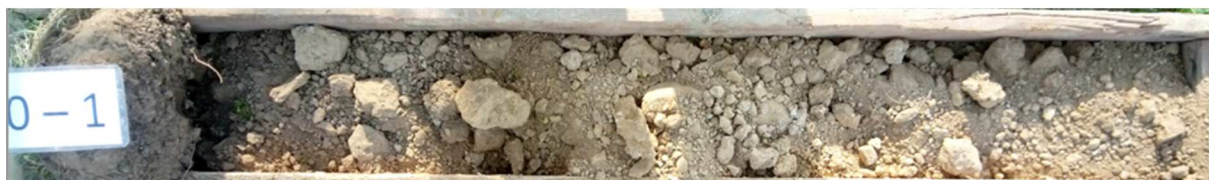
Foto 6 - J112 (hnědozem 0,0 – 0,1 m)

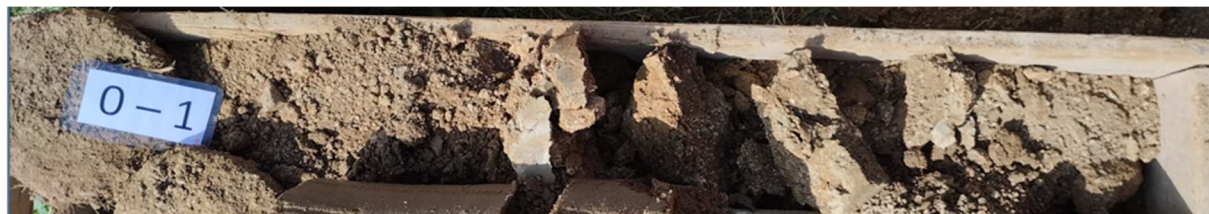
Foto 7 - J113 (hnědozem 0,0 – 0,5 m)

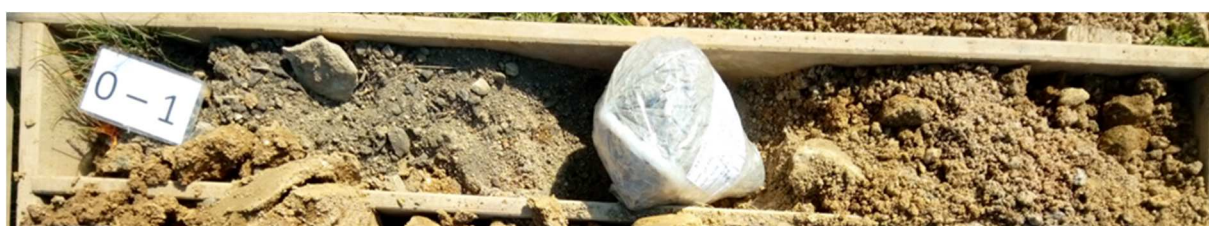
Foto 6 - J115 (navážka 0,0 – 0,6 m)

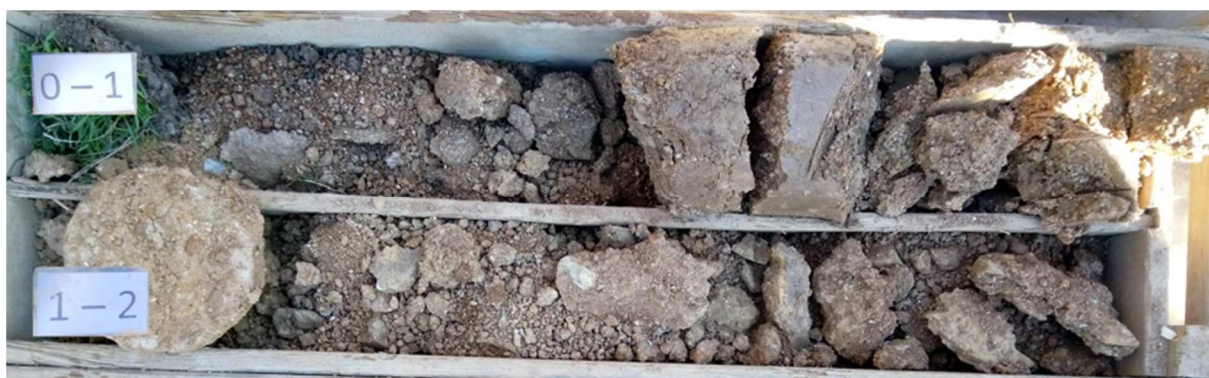
Foto 7 - J120 (hnědozem 0,0 – 0,1 m)

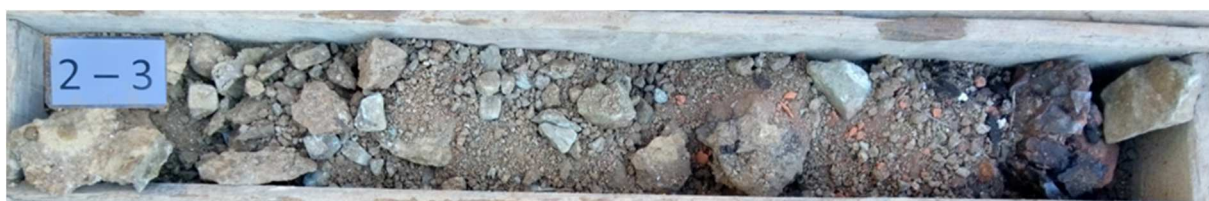
Foto 8 - J122 (hnědozem 0,0 – 0,1 m, navážka 0,1 – 3,0 m)

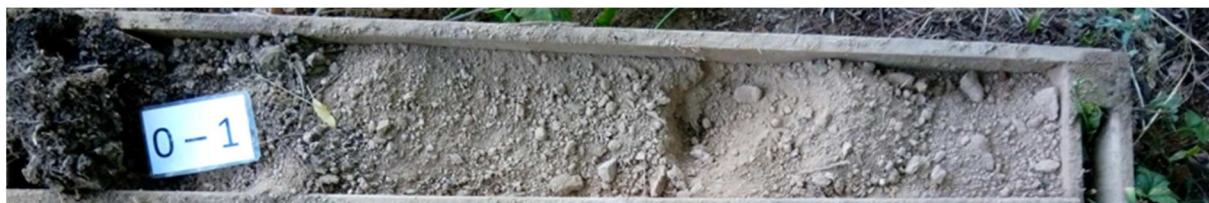
Foto 10 - J125 (kambizem 0,0 – 0,1 m)

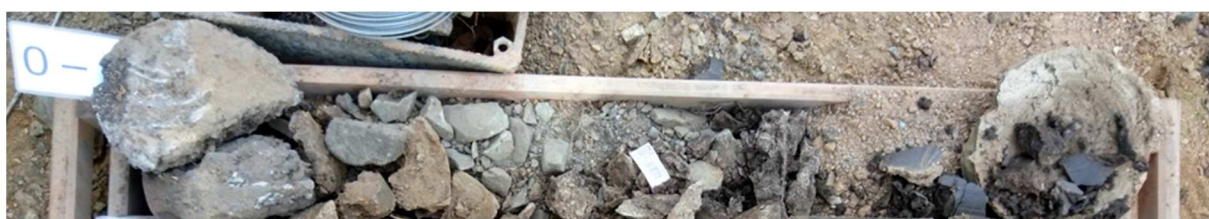
Foto 11 - J130 (navážka 0,0 – 1,0 m)

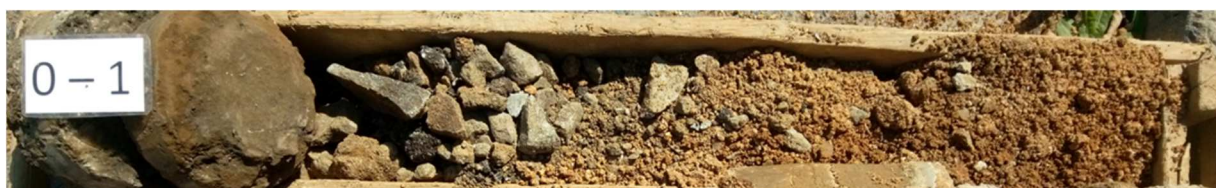
Foto 12 - J131a (navážka 0,0 – 0,7 m)

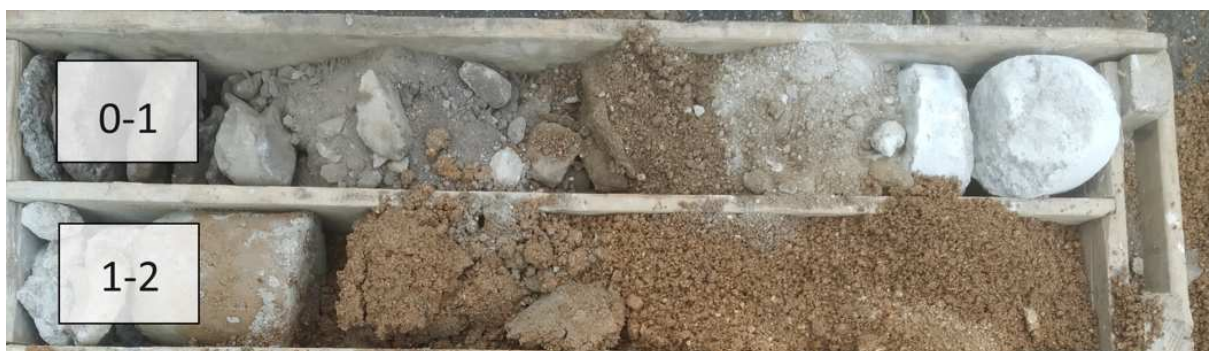
Foto 13 - J132 (navážka 0,0 – 0,8 m)

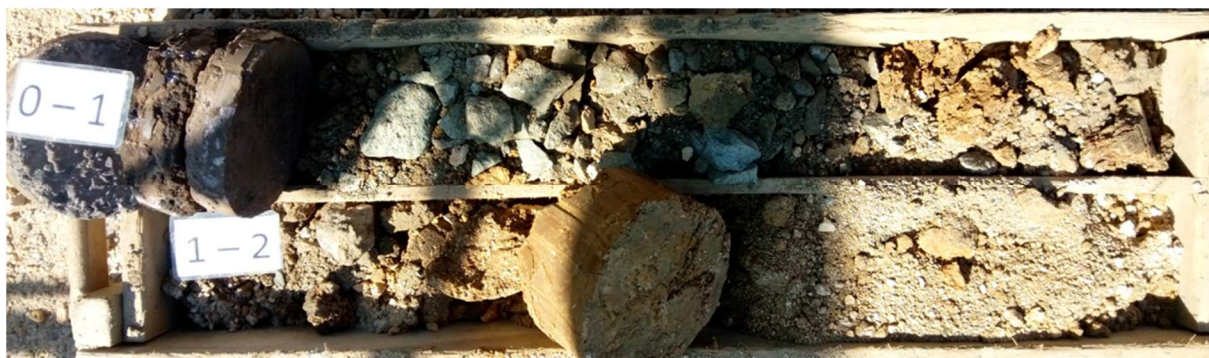
Foto 14 - J134 (navážka 0,0 – 1,3 m)

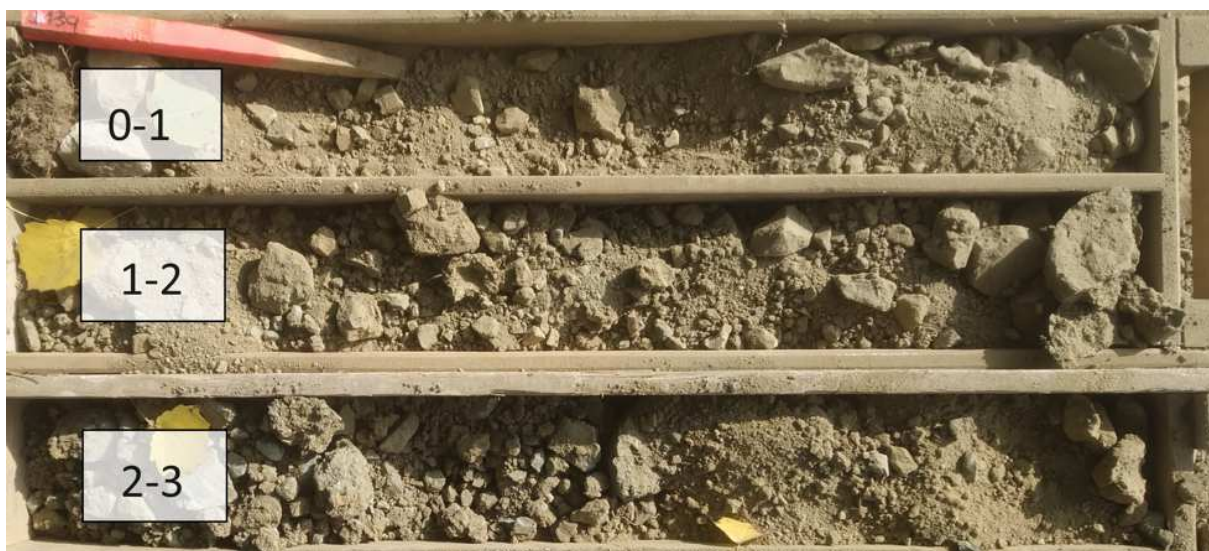
Foto 15 – J139 (navážka 0,0 – 2,6 m)

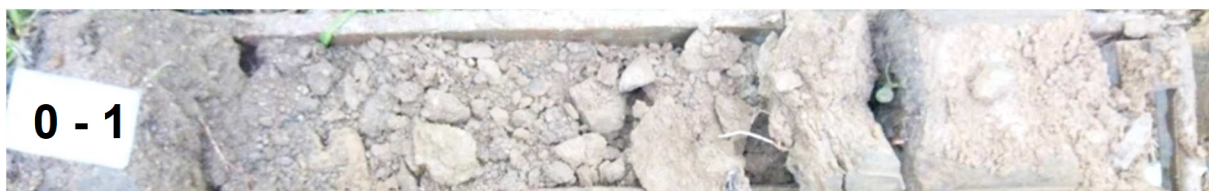
Foto 16 - J140 (kambizem 0,0 – 0,2 m)

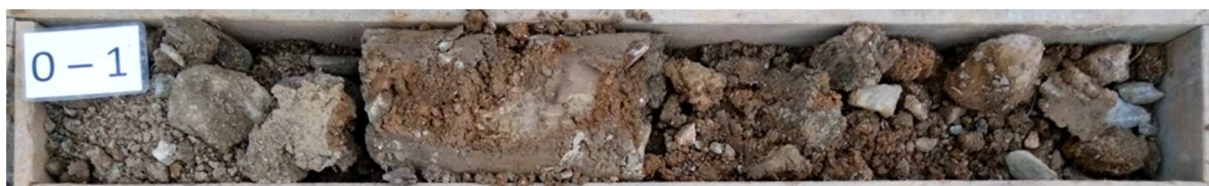
Foto 18 - J142b (navážka 0,0 – 0,1 m)

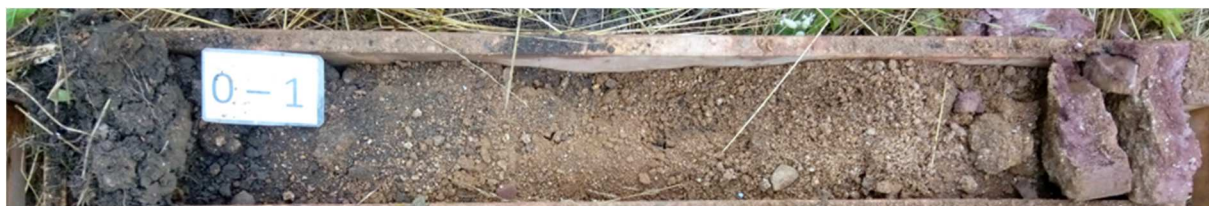
Foto 19 - J145 (kambizem 0,0 – 0,2 m)

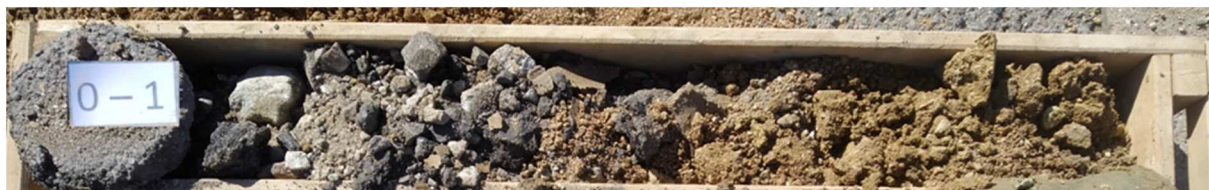
Foto 20 - J146 (navážka 0,0 – 0,4 m)

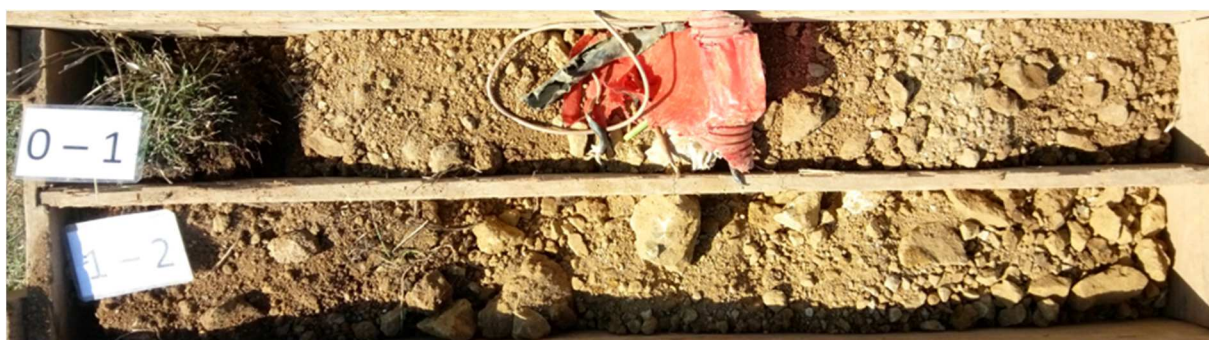
Foto 21 - J147 (hnědozem 0,0 – 0,1 m, navážka 0,1 – 2,0 m)

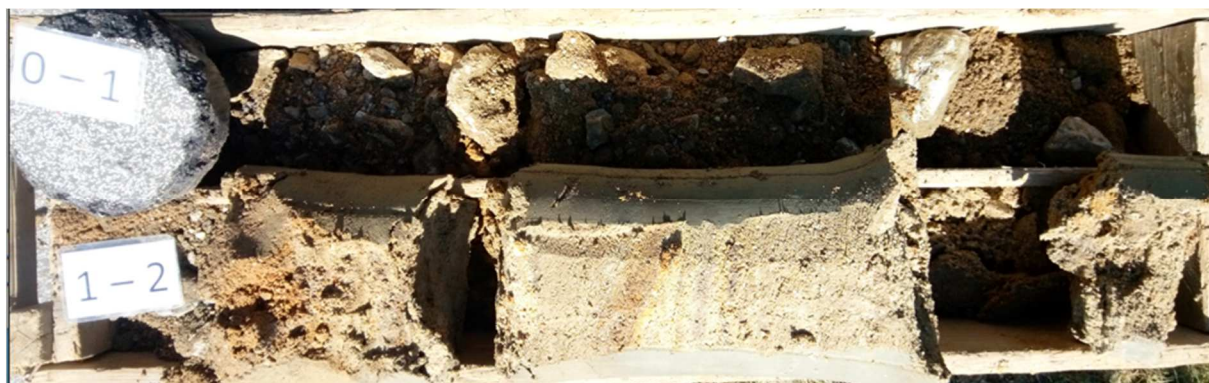
Foto 23 - J149 (asfalt 0,0 – 0,06 m, navážka 0,06 – 1,1 m)

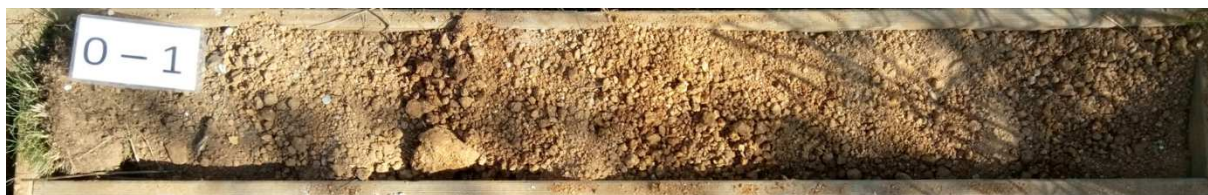
Foto 24 – INK118 (hnědozem 0,0 – 0,05)

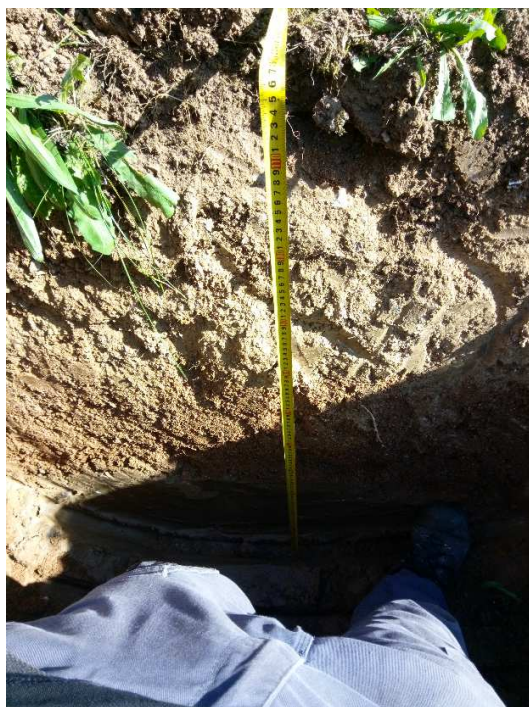
Foto 25 – Profil sondy KS135 (hnědozem 0,0 – 0,1 m)

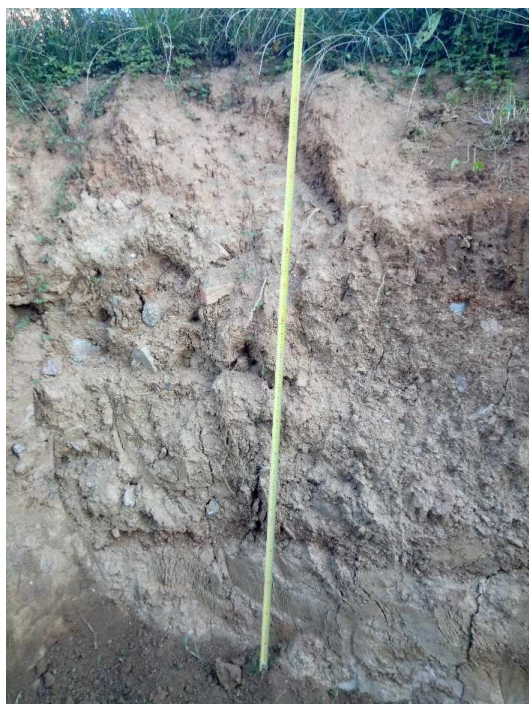
Foto 26 – Profil sondy KS136 (hnědozem 0,0 – 0,1 m, navážka 0,1 – 2,1 m)

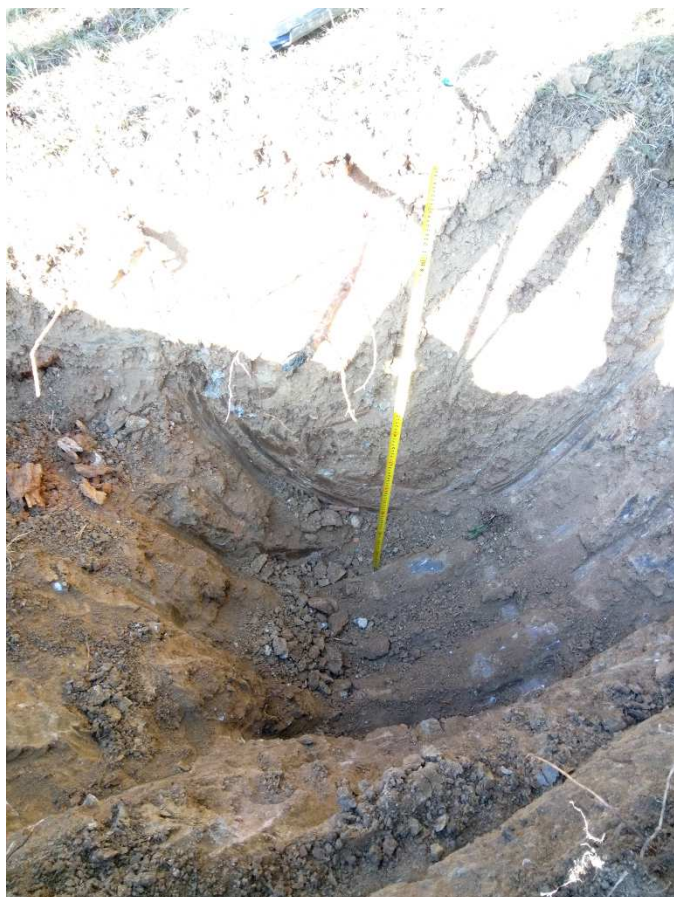
Foto 27 – Profil sondy KS137 (hnědozem 0,0 – 0,1 m, navážka 0,1 – 1,1 m)

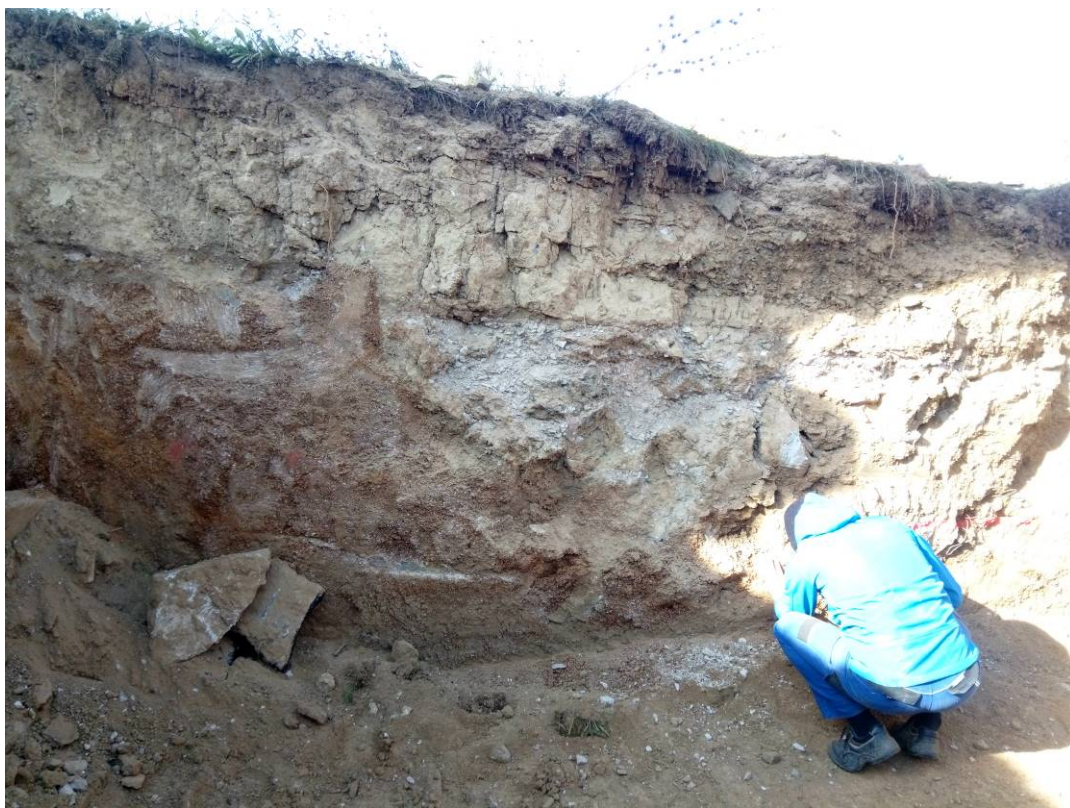
Foto 28 – Profil sondy KS151 (hnědozem 0,0 – 0,15, navážka 0,15 – 0,9 m)
